# **Assessment of Dam Safety of Coal Combustion Surface Impoundments**

**Indianapolis Power & Light Company**

**Petersburg Generating Station**

**November 15, 2010**

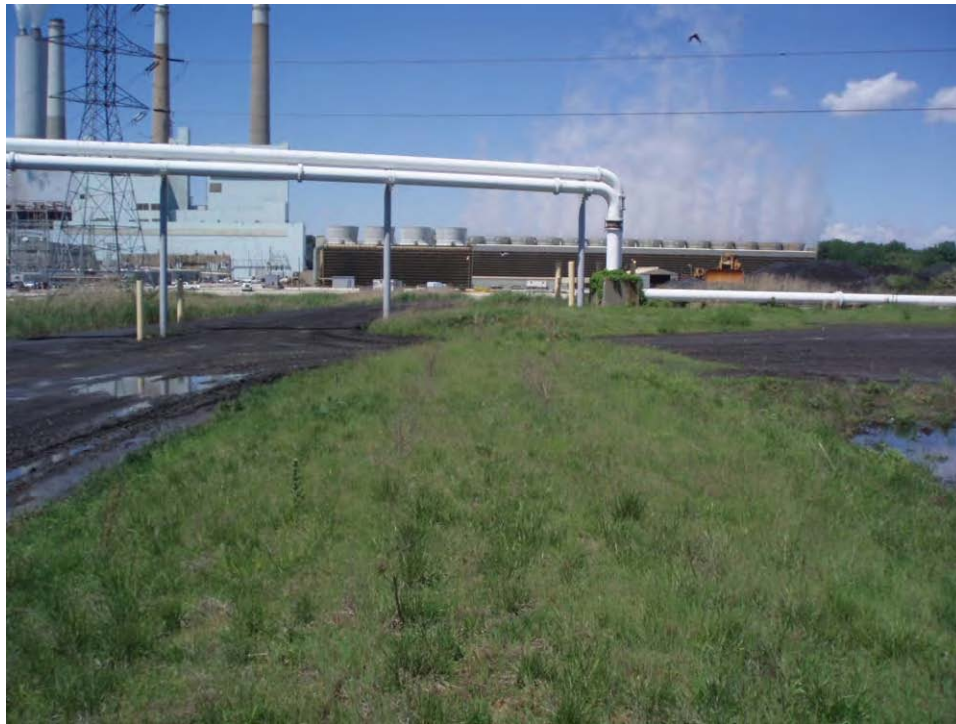
10. Pond A – South embankment crest, looking west. Note access ramp excavated in crest to access the sluice pipes.

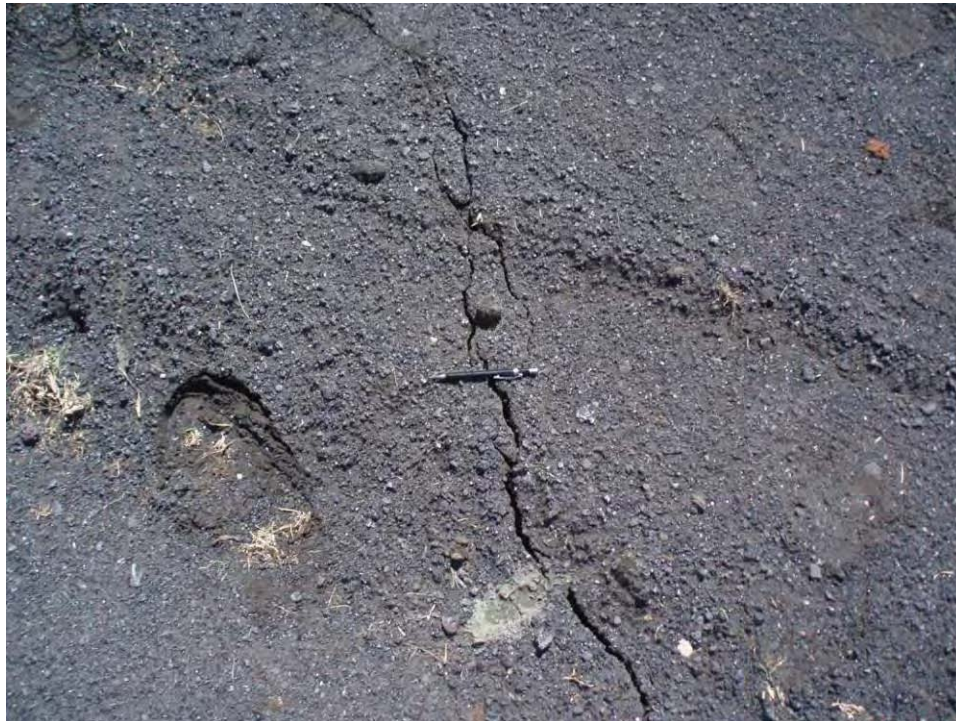
18. Pond A – Surface cracks in recently placed ash material on south embankment crest.

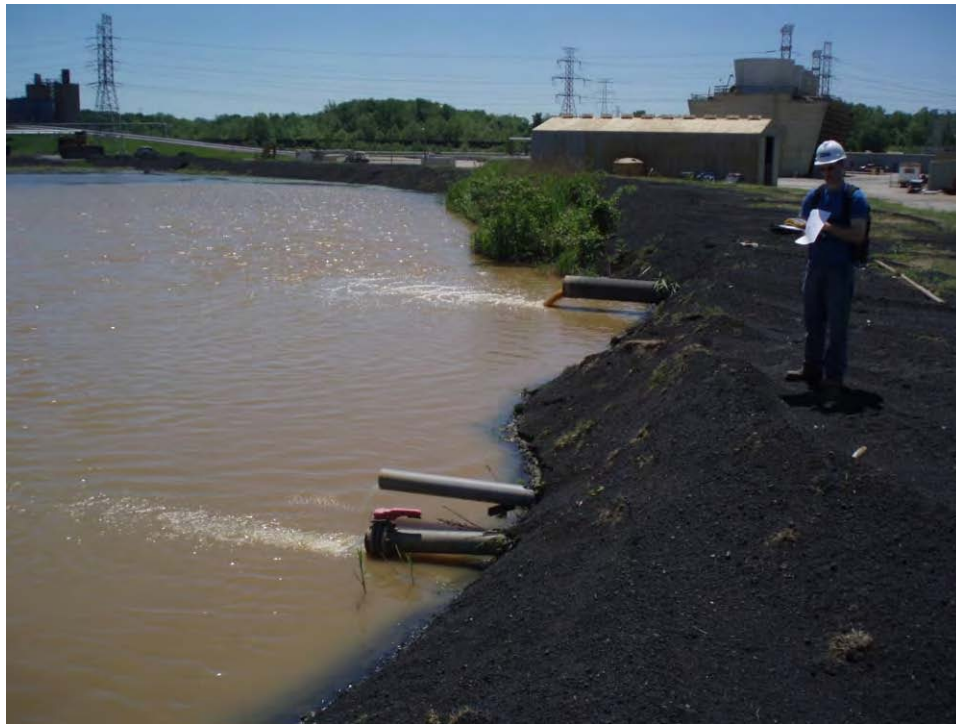
During the site visit, four sets of sluice pipes were observed. The CCW sluice pipes on the south embankment appeared to be in fair condition (Photo 8). The two sets of active sluice pipes on the west embankment (Photo 20) and at the west embankment headwall also appeared to be in fair condition (Photo 36). A fourth set of inactive or abandoned pipes appeared to be in poor condition (Photo 30, 33, and 35). The IPL staff did not know the origin or purpose of these pipes. The excavator operator placed ash over the 24-inch-diameter RCP at the fourth set of pipes.

20. Pond A – West embankment interior slope, looking south at one (1) 12-inch-diameter DI pipe and two (2) 8-inch-diameter steel pipes from plant.

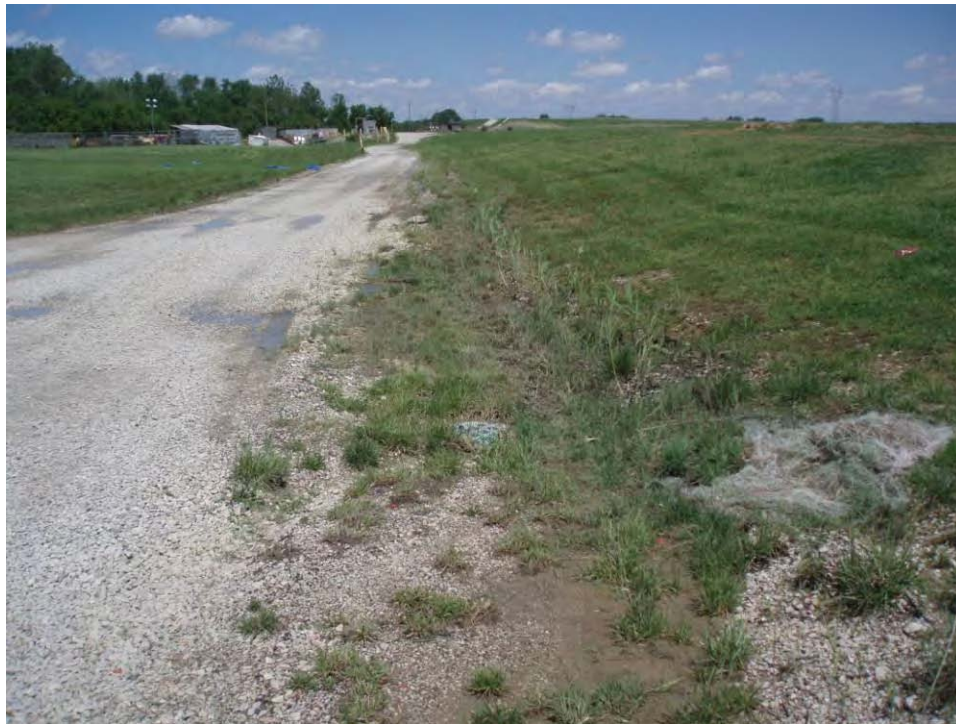
24. Drainage ditch at toe of Pond A west embankment. Note ditch has sparse vegetation.

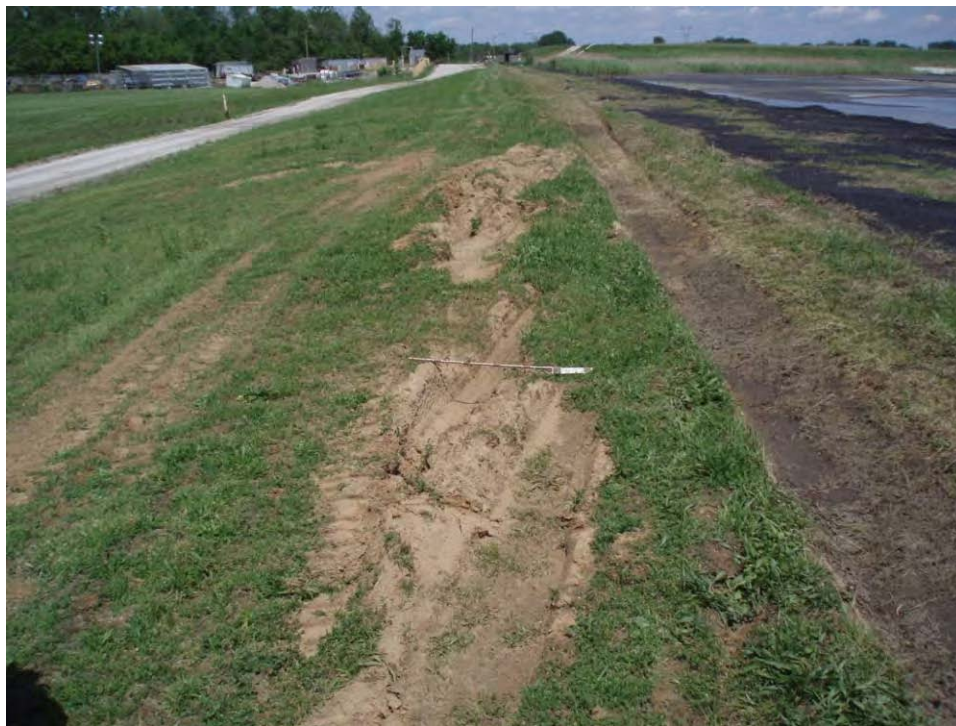
The crest of Pond A generally appeared to be in fair condition (Photos 1, 3, 4, 9, 10, 11, 12, 14, 49, 62, and 64). The crest was approximately 20 feet wide. The crest is surfaced with a compacted gravel access road on the north and east embankments. The crest on the south and west embankments were generally covered with grass approximately 6 to 12 inches tall. The crest around the sluice pipes on the south embankment was covered with ash (Photos 12 and 14). An access ramp excavated into the crest near the sluice pipes on the south embankment was observed (Photo 10 and 12). Track marks from an excavator were observed on the crest of the west embankment (Photos 26, 27, and 29).

26. Pond A – West embankment exterior slope, looking north at large tractor ruts and excavator tracks.

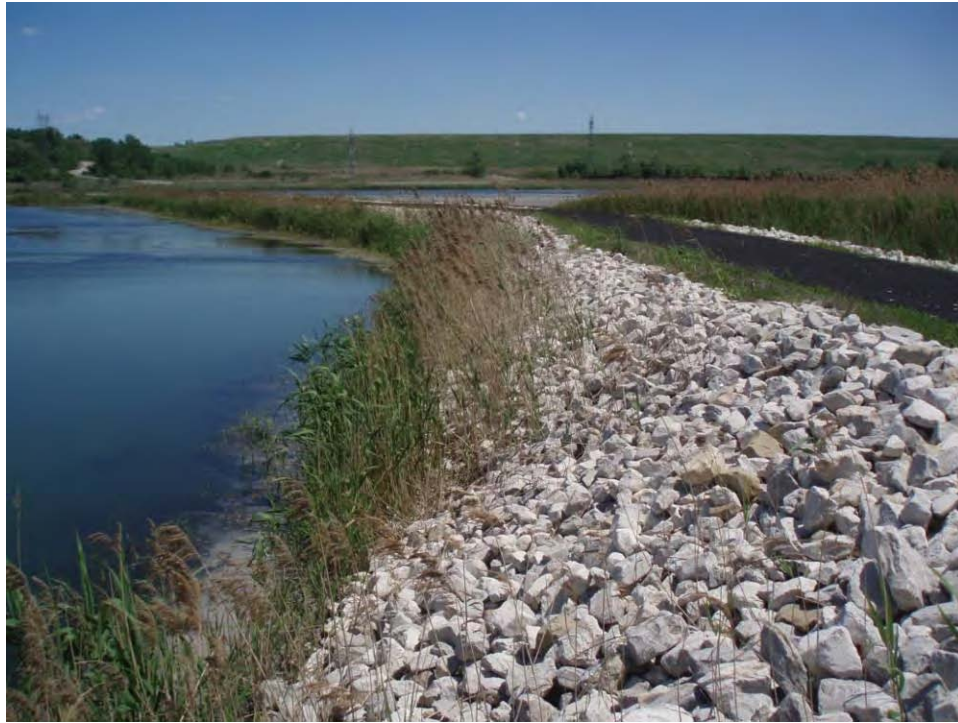
The exterior slopes appear to be in fair condition. The exterior slopes on the south and west embankments were approximately 3H:1V (Photos 13, 19, 22, 23, 24, 26, 27, 28, and 34). The north exterior slope on the divider embankment between Pond A and Pond A – Discharge was approximately 2H:1V (Photos 37 and 47).

The visible portions of the interior slope generally appeared to be in fair condition (Photos 37, 41, 42, 43, 44, 47, and 65). The interior slopes on the north and west embankments were approximately 3H:1V slope and approximately 2H:1V along the divider embankment. Tall, thick wetland vegetation up to 8 to 10 feet tall obscured the observation of north and west embankment and the divider embankment. Riprap armor was observed on the north slope of the divider embankment and around the outlet structure.

37. North slope of divider embankment between Pond A and Pond A - Discharge, looking east.

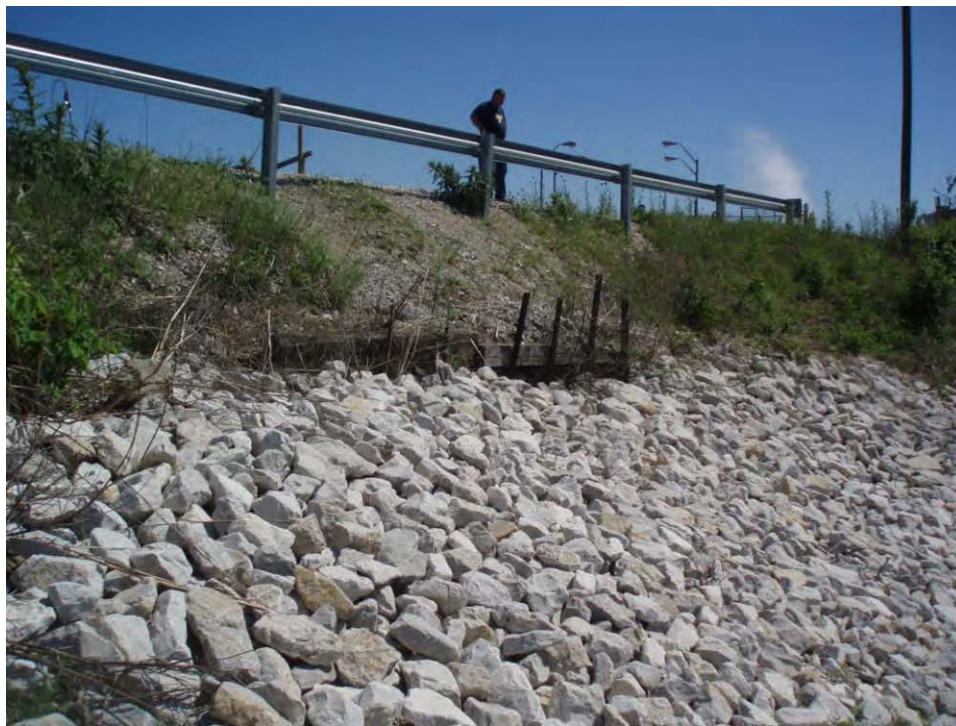
The exterior slopes appear to be in fair condition. The exterior slope on the west embankment was approximately 3H:1V (Photos 70 and 71). The embankment was generally covered with riprap armor to approximately 5 feet below the crest. Some bare spots were observed above the riprap armor. Some metal stakes with 2"x4" lumber were observed above the riprap. The depth of the stakes and lumber, as well as their purpose, is unknown. No erosion or other deficiencies were observed on west embankment during the site visit.

70. Pond A - Discharge, southwest embankment exterior slope looking at steep slope above outfall repaired recently with riprap.

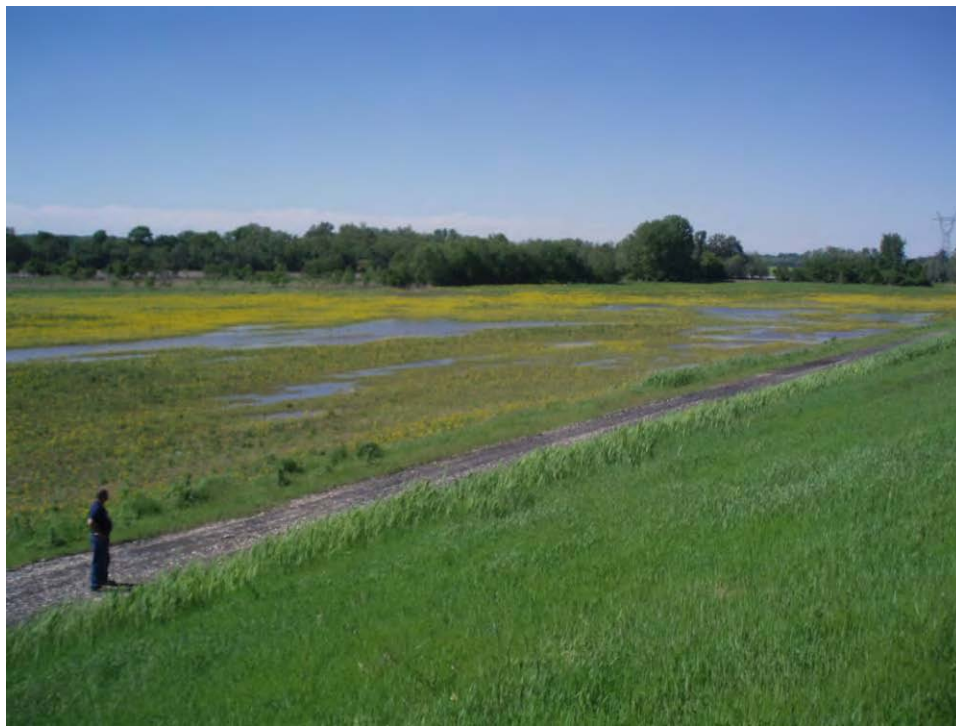
The floodplain at the toe of the west embankment was saturated and flooded from recent storm events (Photos 77, 78, and 84). Possible seepage was observed at the toe of the south embankment and the bench of the west embankment (Photos 63 and 79).

84. Overview of Pond B – West embankment, downstream area, looking northwest. Note field area is flooded from recent storm events.

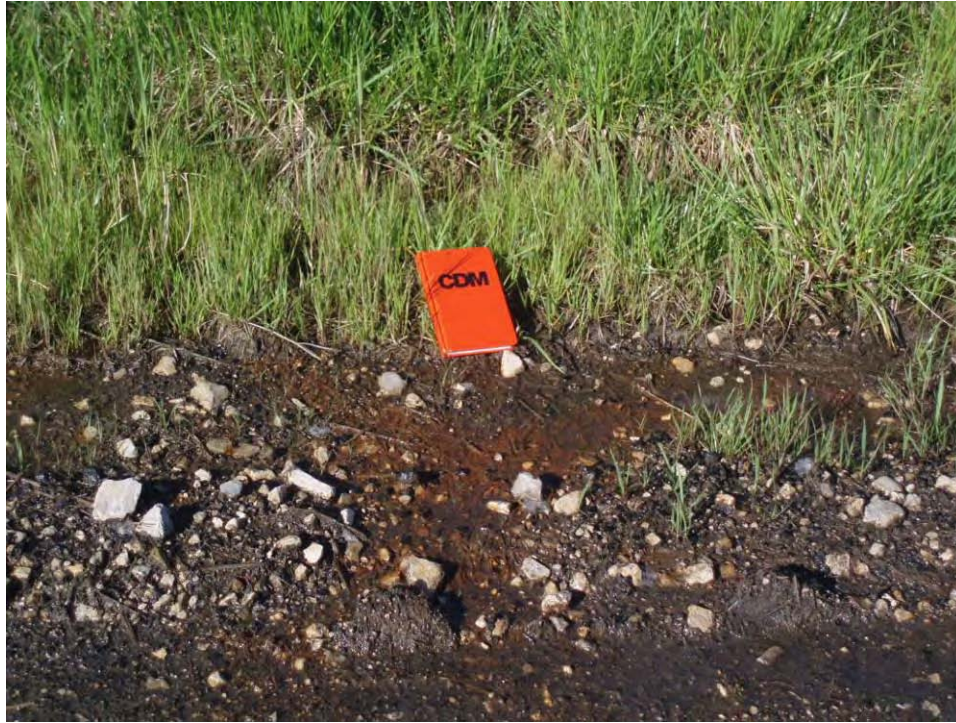
125. Pond C - North embankment bench, looking at active seepage located at toe of upper exterior slope. Note the iron staining in the water

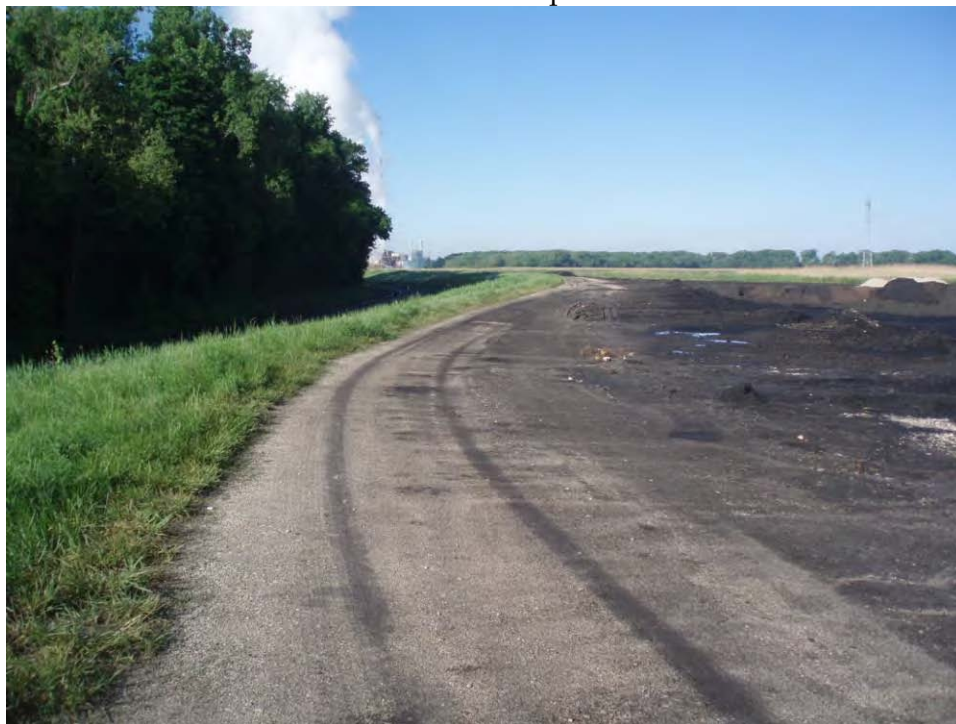
Tractor ruts were observed on the exterior slopes near the crest (Photos 119 and 128) in the very soft, fine-grained, stabilized FGD.

128. Pond C -East embankment crest, looking southwest. Note tire rutting was observed in very soft stabilized FGD near the crest.

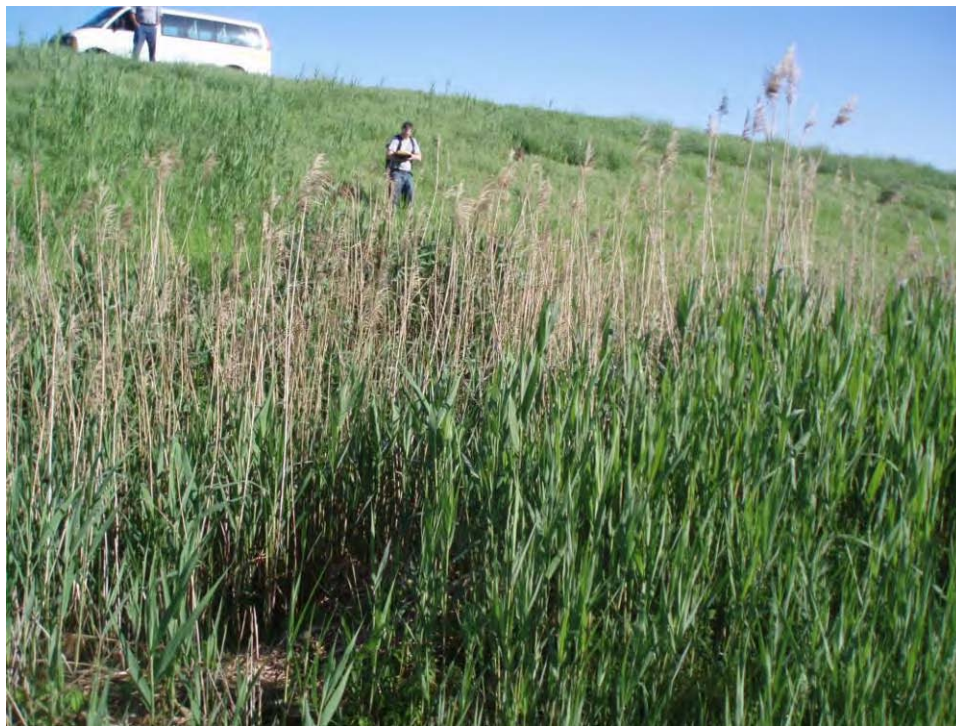
129. Pond C – East embankment exterior slope, looking at area of outlet pipe from outlet structure. Note water was flowing from outlet pipe into drainage ditch.

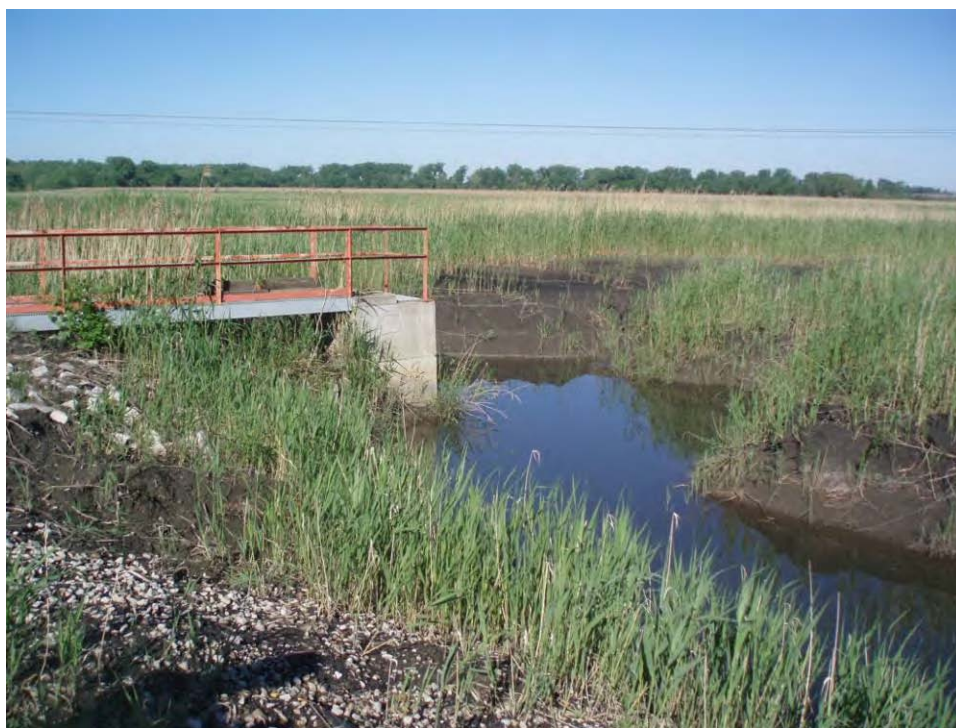
132. Pond C - Outlet structure with stoplogs, looking southwest. Note water level 6.6' below crest at outlet.

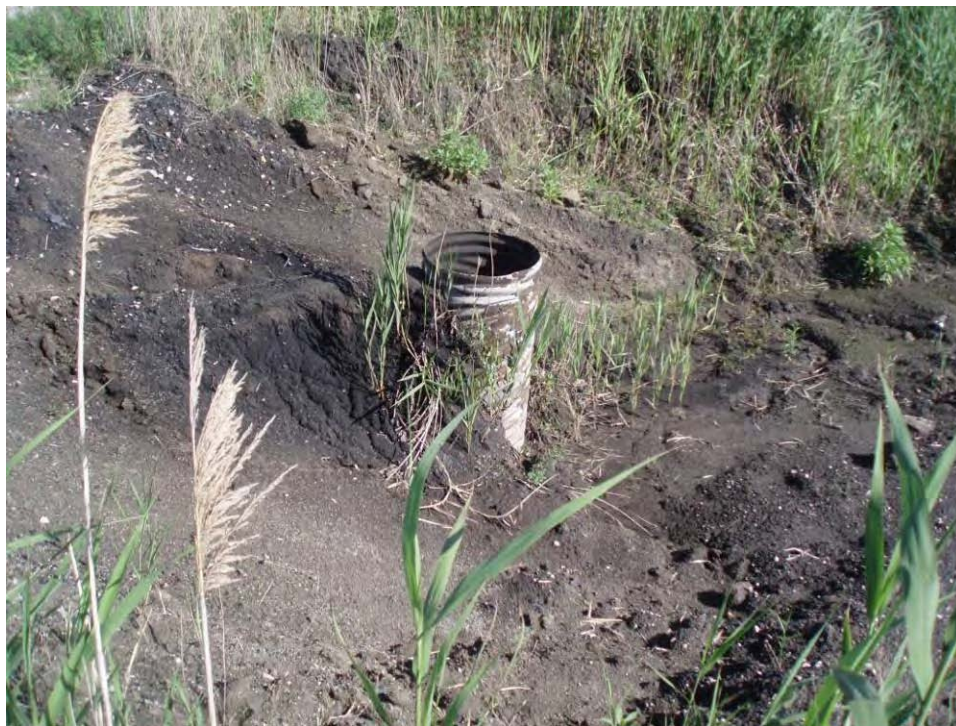
141. 24-inch-diameter CMP equalizer pipe from Pond C to Pond B. Note inlet has a T connection on the end of the pipe.

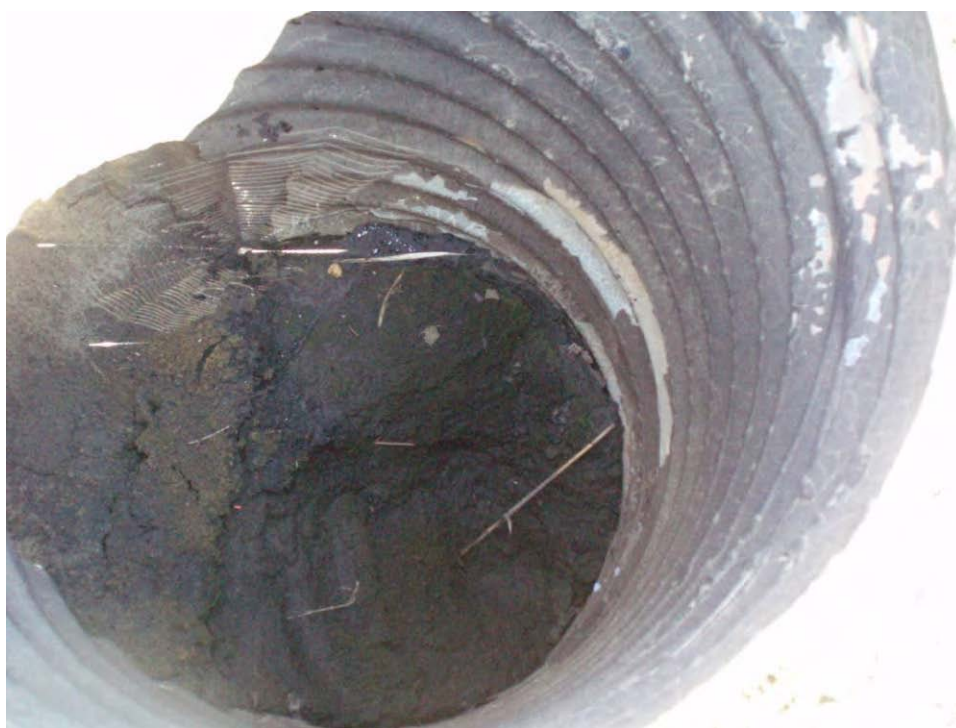
142. Inside of equalizer pipe at Pond C. Note approximately half of the pipe is filled ash.

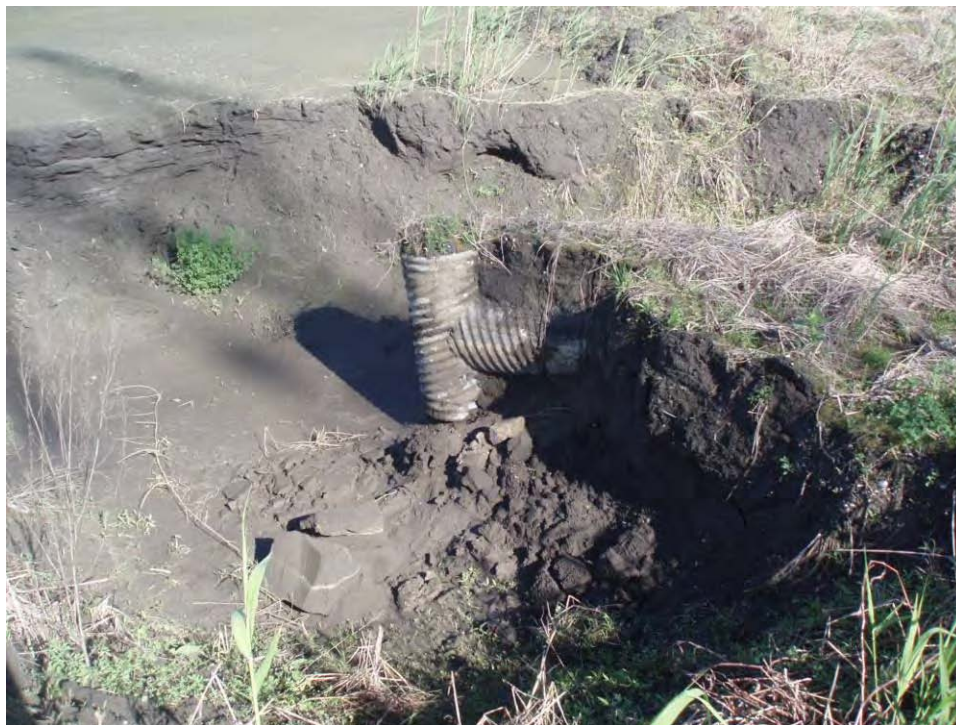
The equalizer pipe in Pond B was in poor condition (Photo 146). The "T" at the end of the pipe was filled to the top with ash.

146. 24-inch-diameter CM equalizer pipe from Pond B to Pond C. Note inlet has a T connection on the end of the pipe and is filled with ash.
